# Manhole Inspection Summary

Manhole # S17Y\_\_007MH

Insp Date: **6/30/08 1:12 PM**

**Location** Address: **1601 desoto rd**

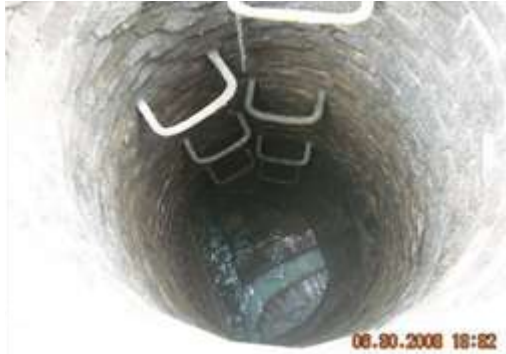
Defect 4

Infiltration: ☐ None ☒ **Joint** ☐ Cracks ☐ Mortar ☐ Roots ☐ Wall

infiltration @ corbel/chimney joint

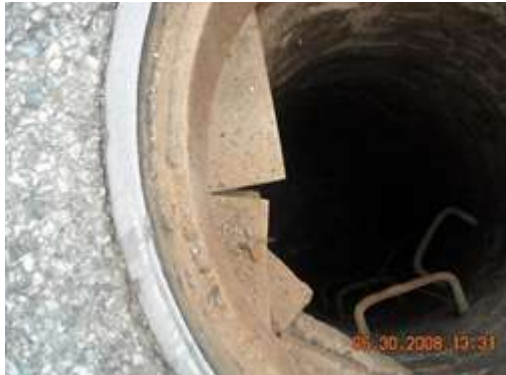
Defect 1

Condition: ☐ Sound ☐ Cracked ☐ Root Intrusion ☒ **Loose Brick** ☐ Deteriorated

loose chimney bricks
